The Peakys Wallers - A Wall in a Day

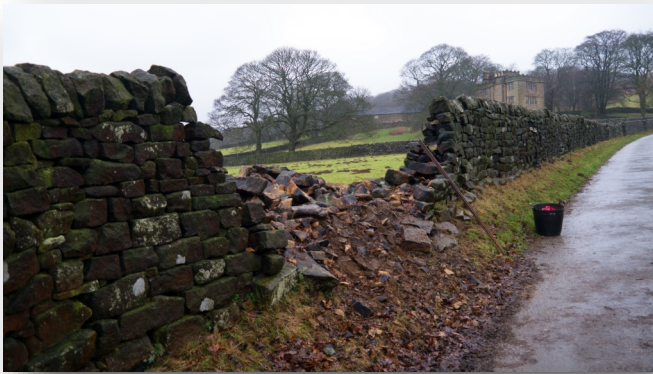
It's February and the weather forecast is not good. Our Challenge - a collapsed section of wall on the track leading to historic **North Lees Hall**. The historic hall, thought to be the basis for Thornfield Hall in Jane Eyre can be seen in the background.

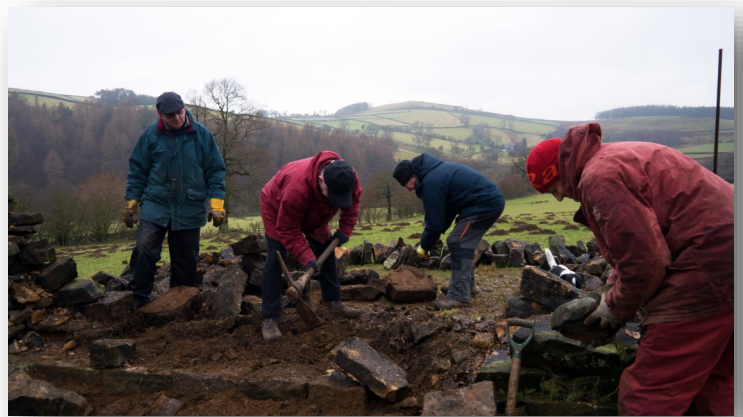
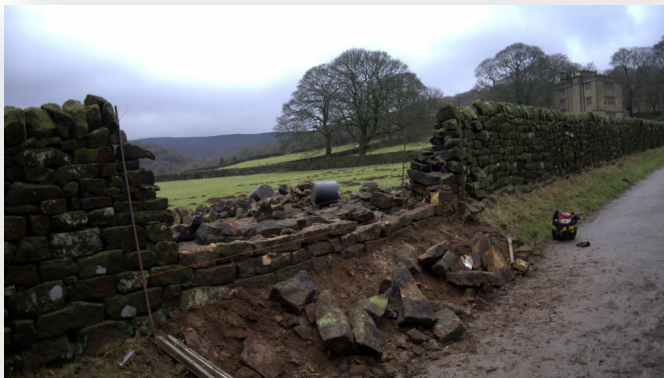
As with all our repairs, the job begins with the unpleasant but necessary task of clearing some working space, sorting the stone, and then putting in new footings where required. As with many jobs, preparation is key.

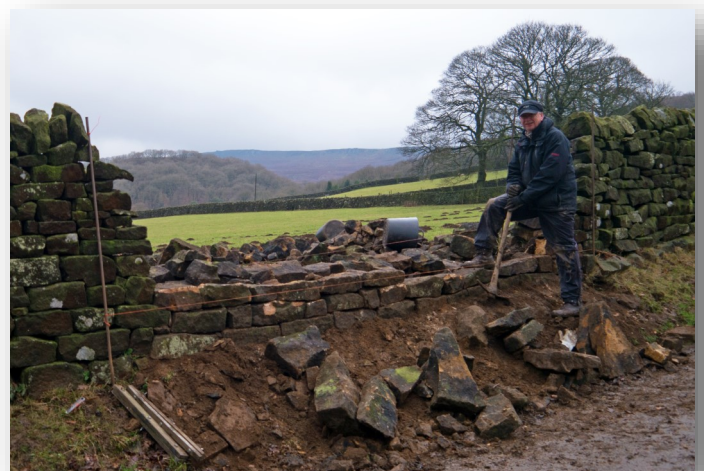
Once the footings are in we begin to put the first courses in. This was a difficult wall because there is a bank from the base to the road, and most of the stone had collapsed on the field side, probably due to earth movement over the years.

The author posing with a mattock, pretending to know what he is doing! The line used to help us keep the courses level can be seen. We would usually use an 'A' frame to ensure the 'batter' (the slope of the wall from top to bottom) was consistent. This was not possible due to the way the wall had collapsed. We did this by eye.

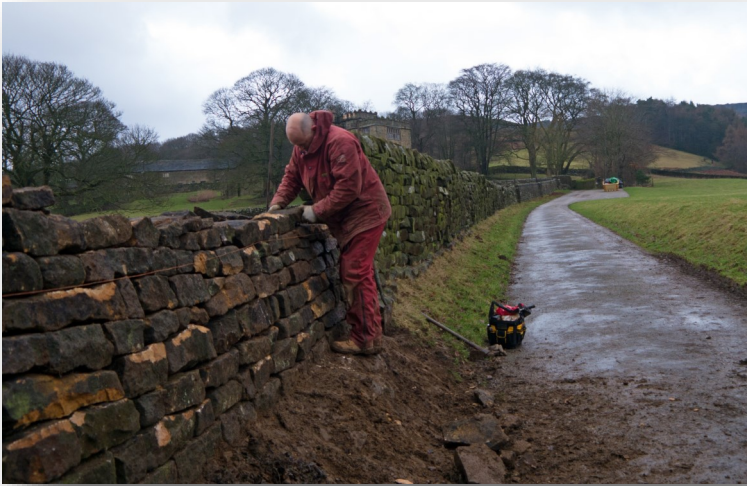
We have learnt so much from this man - Tom Lewis. Tom is a Ranger with the Peak Park and is a demanding taskmaster. He won't settle for a shoddy job - understandable, especially when the wall is in such a public place as this (the road is a very busy footpath leading to Stanage Edge)

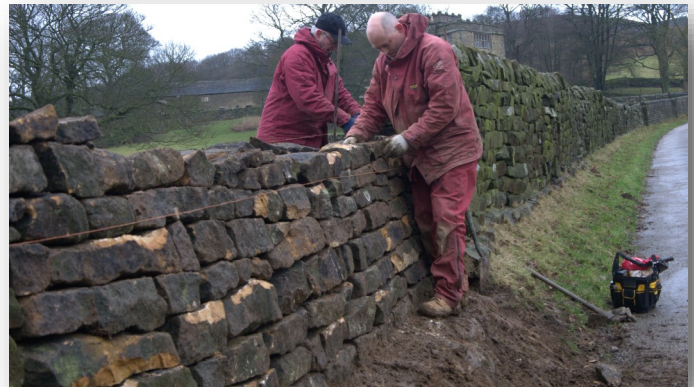
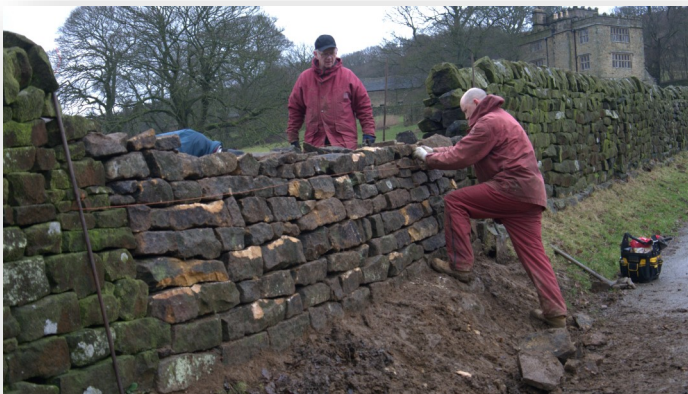
Classic walling! Two people working either side of the wall matching courses as it goes up. Mike Baker is our coordinator and a volunteer Park Ranger. The rest of our group is out of shot, probably sorting stone or making 'hearting' (the small stones that fill the middle of the wall and give it strength).

Mike can only stand and admire Tom's workmanship! The access was very difficult. We had to pass the stone over the wall to Tom as there was little on his side. A number of the stones have been 'faced' with a walling hammer to knock off any protruding lumps. This is not just cosmetic - it helps water run down the batter of the wall and away.

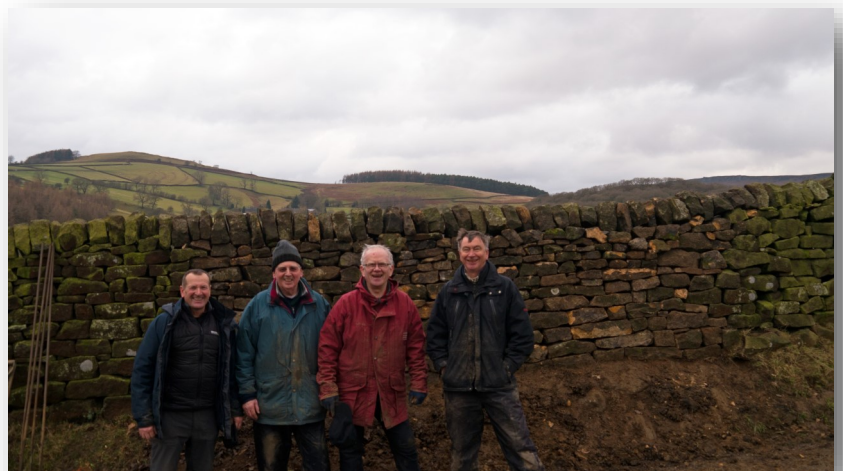
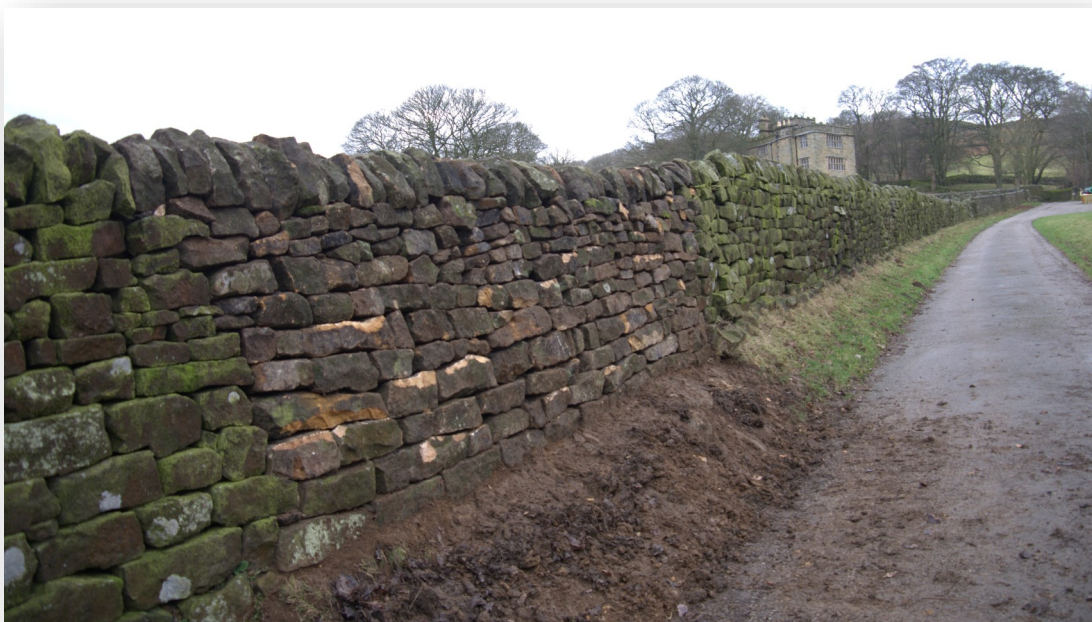
The walling team pose in front of the completed repair. The makeup of our group varies from month to month. Some of us have been walling since the U3A group began. Others are new or just trying it out. We all look happy with the final result!

We finished at about 4.00 pm and the repair 'looks well' as they say in Derbyshire
