The Peaky Wallers

The Story of a Wall (*Part Deux*)

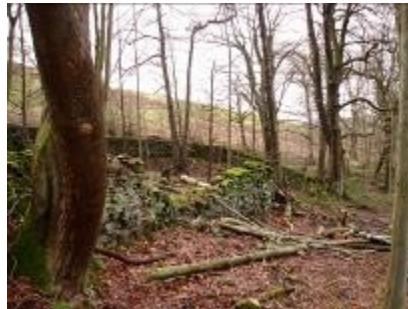
Where we Started

This particular area of woodland was on a slope and not easily accessible. There were a number of underground streams, two of them under the existing wall and this meant some bridging work! Since the wall was originally built (some time in the 1800s) trees had matured (causing the wall to collapse). Despite the fact that the area had been thinned to 40% of the canopy to allow more light in (so bluebells could grow), there were still several trees in our way. Going around the first tree gave us more practice in curved walls!

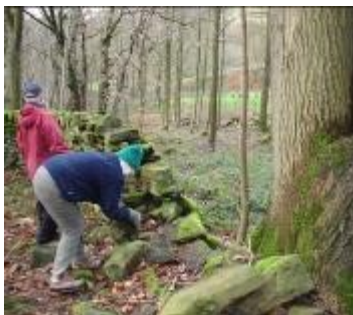
Taking Down The Old Wall

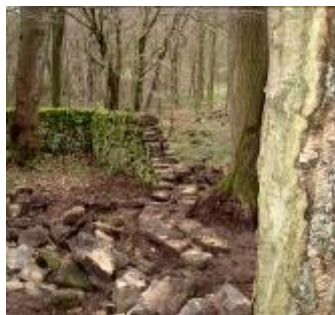
Footings for the Curve

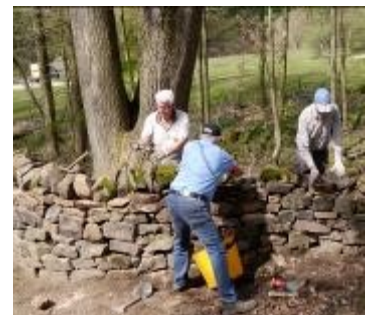
Building Around the Tree

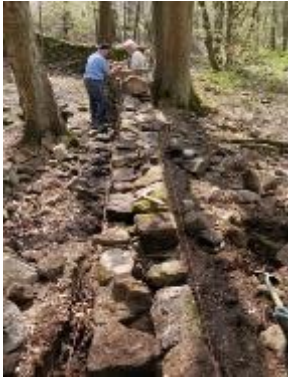
Using 'A' Frame and Lines

We only meet once a month, but we manage to achieve quite a lot each session. The personnel changed each month because of people's commitments. We welcomed new members and others dropped out for a variety of reasons. We have learnt the importance of using lines, and we now understand how to wall on a slope (although there is no photographic evidence of the famous 'teapot' method of ensuring the wall is level along its length!)

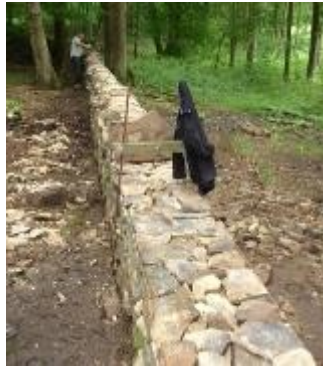
Keeping it Straight!

Once we had rounded the tree we had a good opportunity of putting the above skills into practice on a long 'straight' section. Even though the wall was not a public boundary, Tom impressed on us the importance of the aesthetic appearance of the wall which was not easy as the stone we had to work with was extremely rough (Tom used a highly technical term for this - "Rubbish").

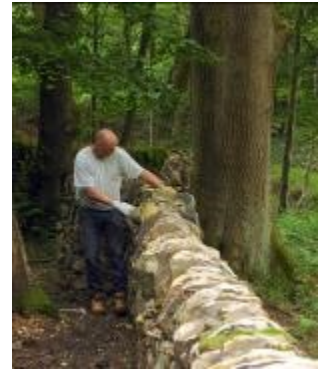
Tidying the Coping Stones

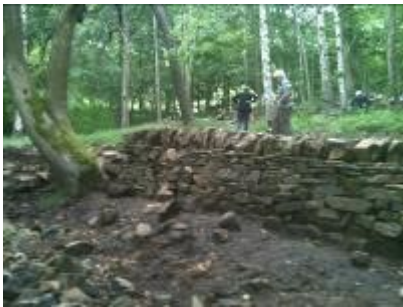
The Second Tree

The situation of the second tree meant we were unable to round it, so it was decided to utilise two 'Cheek Ends' either side. This provided good experience, especially for new members of the group who had not had the chance to build these before. Although there is obviously a gap between the cheek end and the tree, this is not critical in this particular wall as it is not a boundary and not used for stock control. However, once again, the poor selection of stone made the task more difficult.

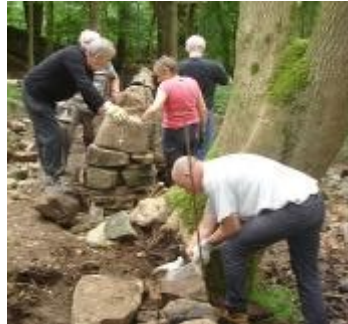
Working on the Cheek End

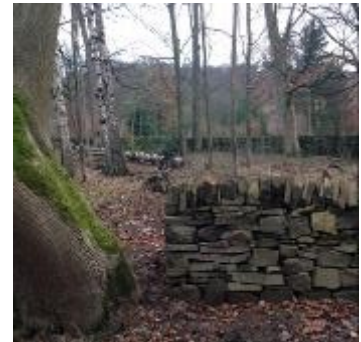
Completed Cheek End

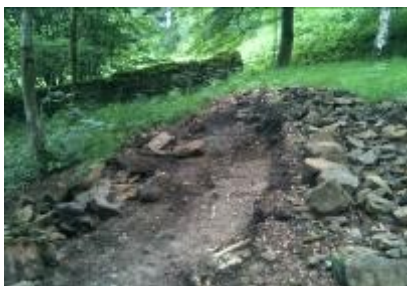
Footings For the Extension

From the tree we were struggling to find suitable stone. It did look as though the wall would not be able to span the entire length to join the existing corner of the further wall. At this point, Bill made an interesting discovery - the route of an ancient 'hollow way' that crossed the site. After research, it became clear that the wall adjacent to the one we were repairing had been built across the route, and that one of two large gate stones was built into this wall. It was decided to restore this route through the woodland and a section of wall was taken down. This had the dual effect of restoring the hollow way and providing us with some much needed stone. Enough, in fact to complete the wall.

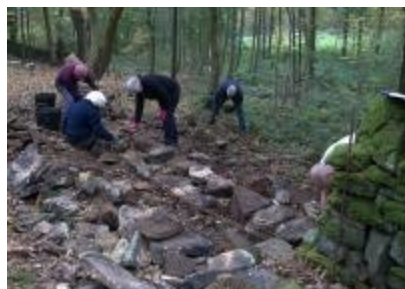
Joining to the Existing Wall

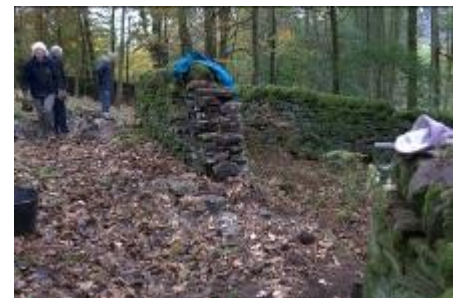
Restoring the Hollow Way

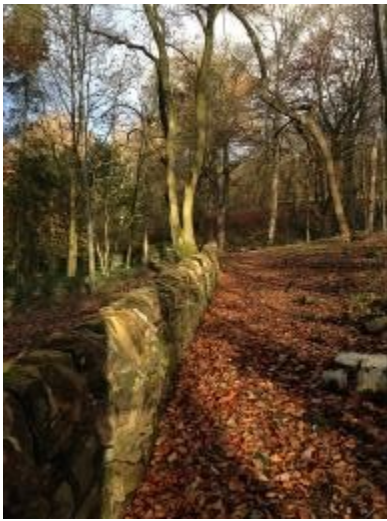
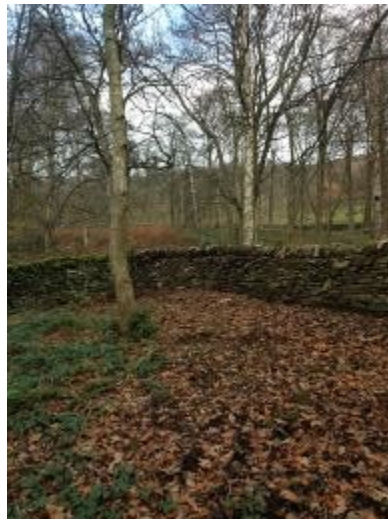
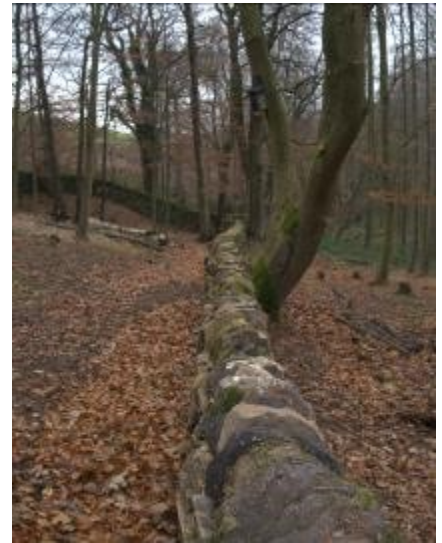
The Finished Wall - 60 Metres

We completed the Wall in December. This was our final repair job at North Lees. It is a wonderful setting, and we have been privileged to work there through all seasons. The surrounding scenery and wildlife is wonderful and we have seen the campsite itself benefit from the addition of the camping pods and refurbished shower and toilet facilities. Our walls are only a small part of this, but it is a wonderful thought that the walls we have repaired contribute to the environment and that they will hopefully be appreciated for years to come.
