Geology and the A55 North Wales Coast Road

A variety of difficult ground conditions caused many problems during the upgrading of the A55. This talk will explain these problems and how they were overcome.

Frank Nicholson

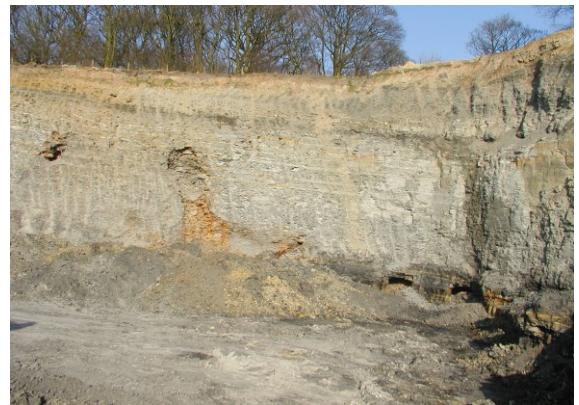
Void migrating upwards in Opencast face – potential serious subsidence.

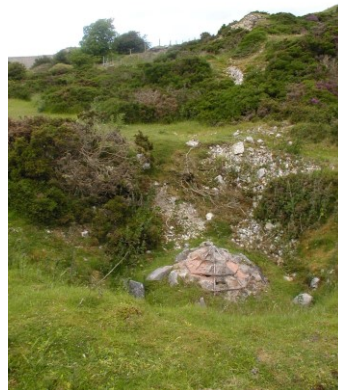
Capped mine shaft.
 • 36% of Holywell Bypass in Carboniferous Limestone was affected by old workings in mineral veins.
 • 34 mineshafts capped as part of the road works.
 • Also 10 reinforced concrete rafts needed to stabilise the upgraded carriageway.

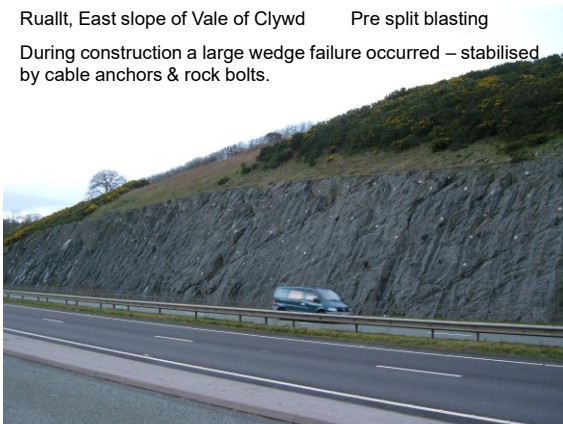
Rock bolts, shotcrete and catch fence.

Ruallt, East slope of Vale of Clwyd Pre split blasting
 During construction a large wedge failure occurred – stabilised by cable anchors & rock bolts.

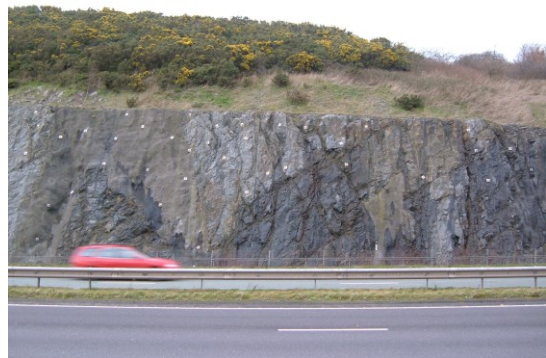
Safety bench and catch fence.

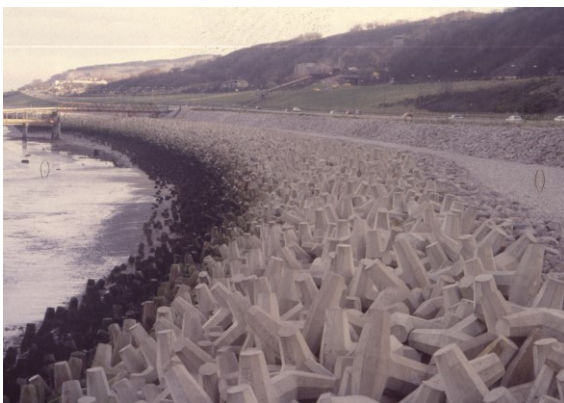
Constructed toe weight embankment needs marine erosion protection

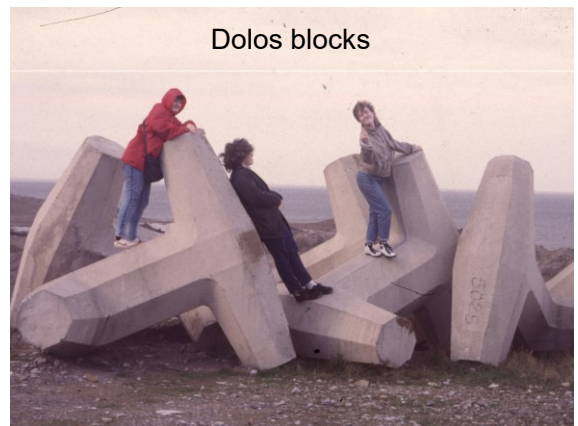
Dolos blocks

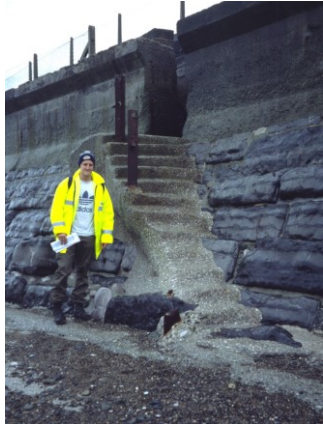
Concrete steps eroded by waves bombarding steps with beach pebbles..

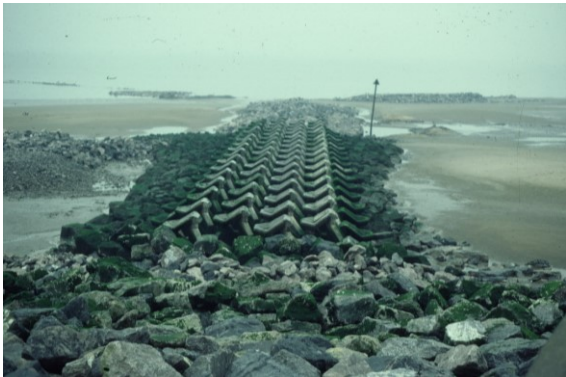
Breakwater designed to be submerged and absorb wave energy.

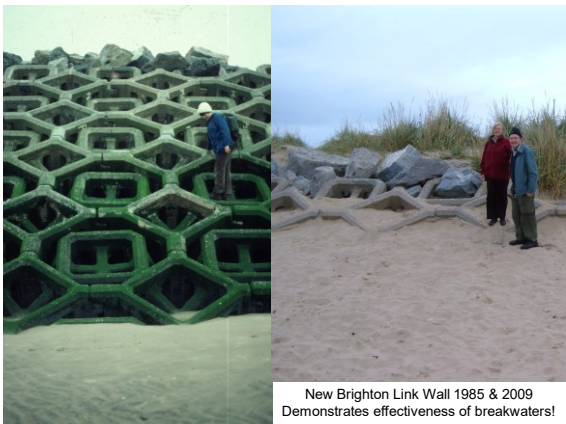
New Brighton Link Wall 1985 & 2009 Demonstrates effectiveness of breakwaters!

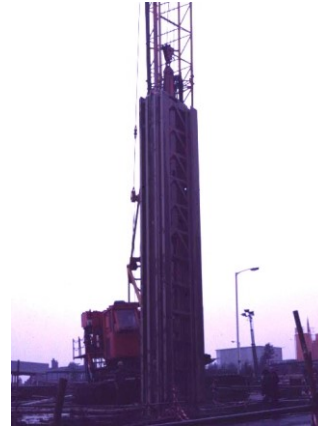
Frame for making a diaphragm wall.
 The trench walls need support as they are dug.
 The trench is filled with bentonite (a clay with special properties - thixotropic).
 The side support is withdrawn.
 Concrete is pumped in, displacing the bentonite.
 Iron reinforcement is added.

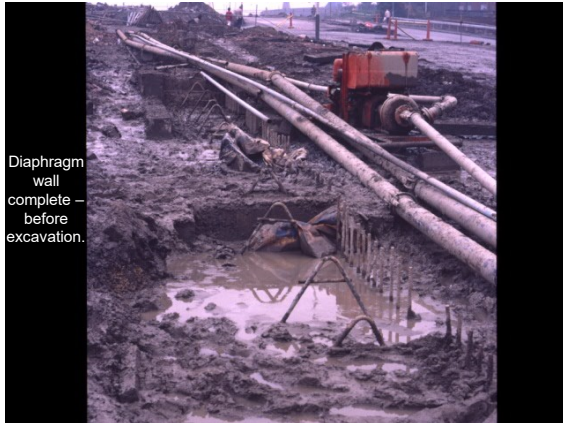
Diaphragm wall complete – before excavation.

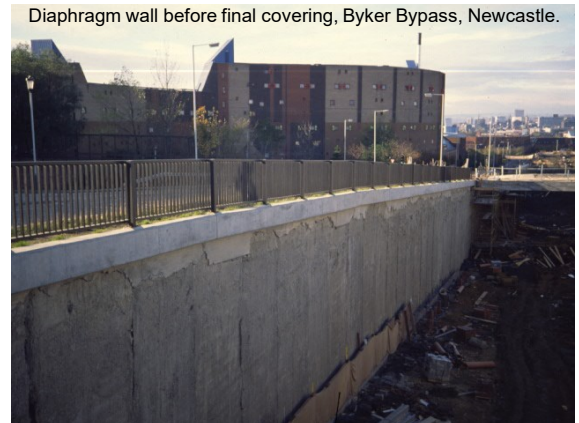
Diaphragm wall before final covering, Byker Bypass, Newcastle.

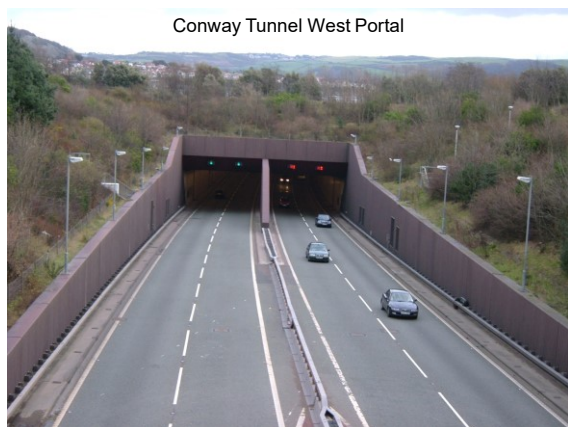
Approach sections of tunnel on each bank were made by cut and cover method (excavate, make concrete tunnel section, cover tunnel by burying).

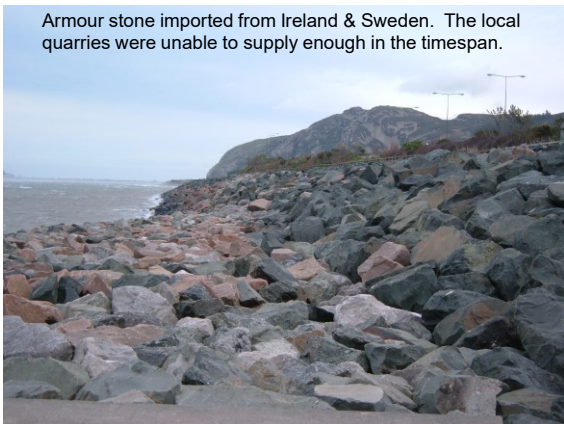
Penmaenmawr Promenade

Armour stone imported from Ireland & Sweden. The local quarries were unable to supply enough in the timespan.

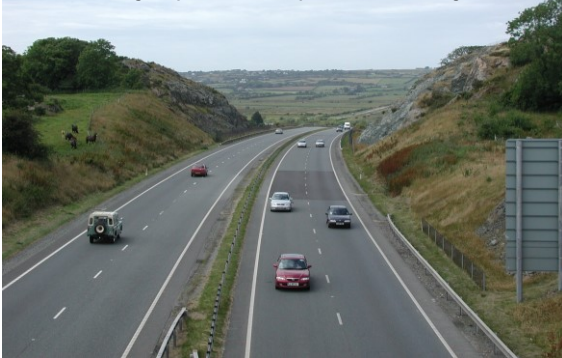
Near Pentre Berw the bedrock changes to hornblende schists which are more resistant to erosion, forming a prominent ridge. This ridge required a 17m deep blasted rock cutting.
