# The Story of a Wall

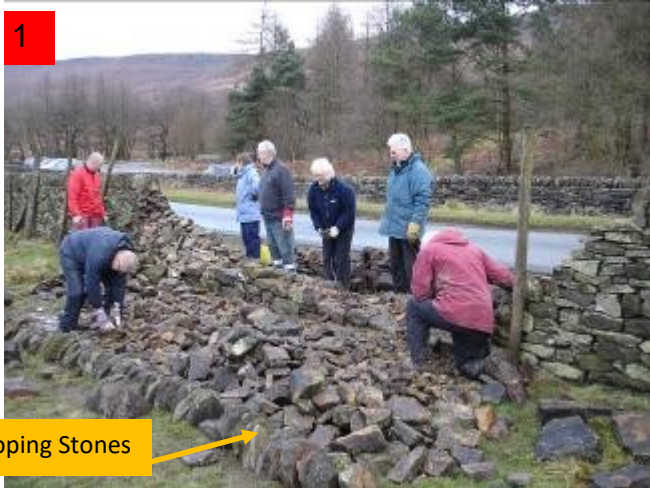
1

Coping Stones

The first job when repairing a section of wall is to recover as much of the original stone as possible, and then sort it and stack it to ensure a safe working area.

The piles of stones in the foreground have been sorted by size to make selection of stones easier.

The **Coping Stones** which go on top of the wall have been carefully placed out of reach so they are not used lower in the wall.

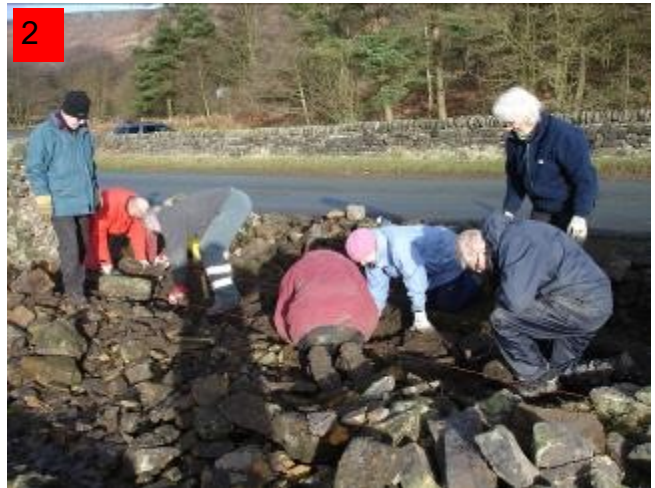
2

After sorting the stones and levelling off, the lines are put in and work begins on creating a firm level foundation. Sometimes this means digging a shallow trench as a starting point.

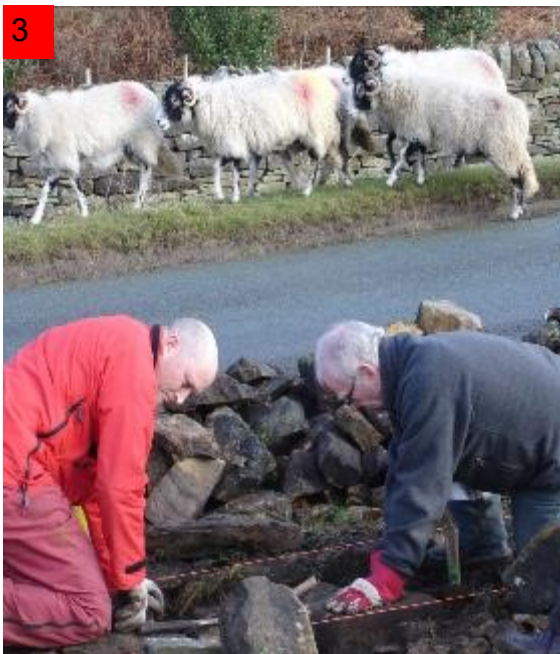
3

Larger stones (usually the big ugly ones!) are used to make the foundation. (Sheep pretending not to notice!)

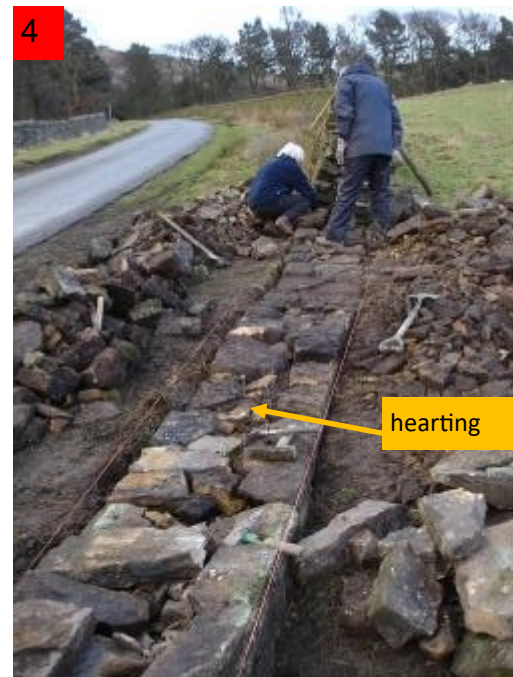
4

hearting

With a lot of hard work, a sound base is created (note use of small stones - **hearting** or filler) to fill gaps and create a strong wall

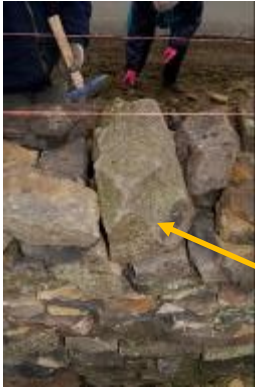
5

Through Stone

Every metre or so, a large stone which spans the wall from one side to another is used. This stone is known as a **Through Stone**.

Through Stones give the wall stability as they help tie the wall together.

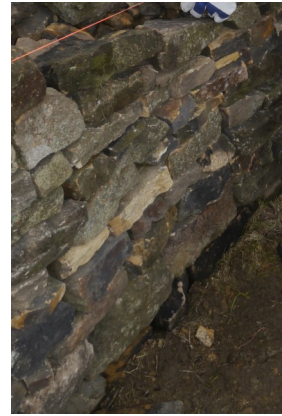
6

When laying the stones, it is vital to ensure that the joints are staggered. If the joints line up vertically over several courses, this will introduce a weak point in the wall and this could cause it to collapse

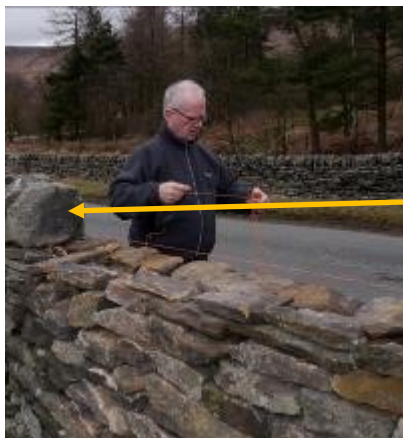
7

Coping Stone

Once the required height is achieved, the top of the wall is levelled off using flat stones and hearting ensuring good base for the **Coping Stones**. When repairing a section of wall (as in this case), a line is used to ensure the tops of the coping stones are level with the original height of the wall..

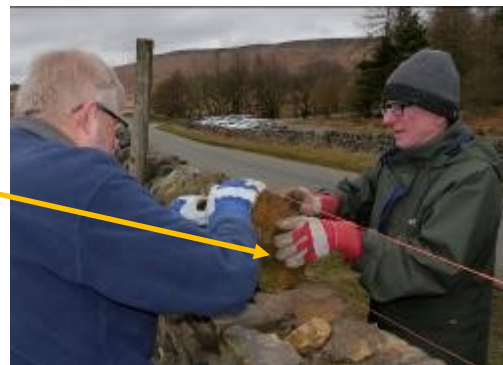
8

Coping Stones may have straight or curved tops, depending on the style of wall. In this case they have a 'pointed' top and a flat bottom. This is because they have been shaped. It is important when repairing a wall to keep all of the original coping stones back so as not to use them in the body of the wall.

The coping stones are either placed vertically, or leaning slightly depending on the style of the wall

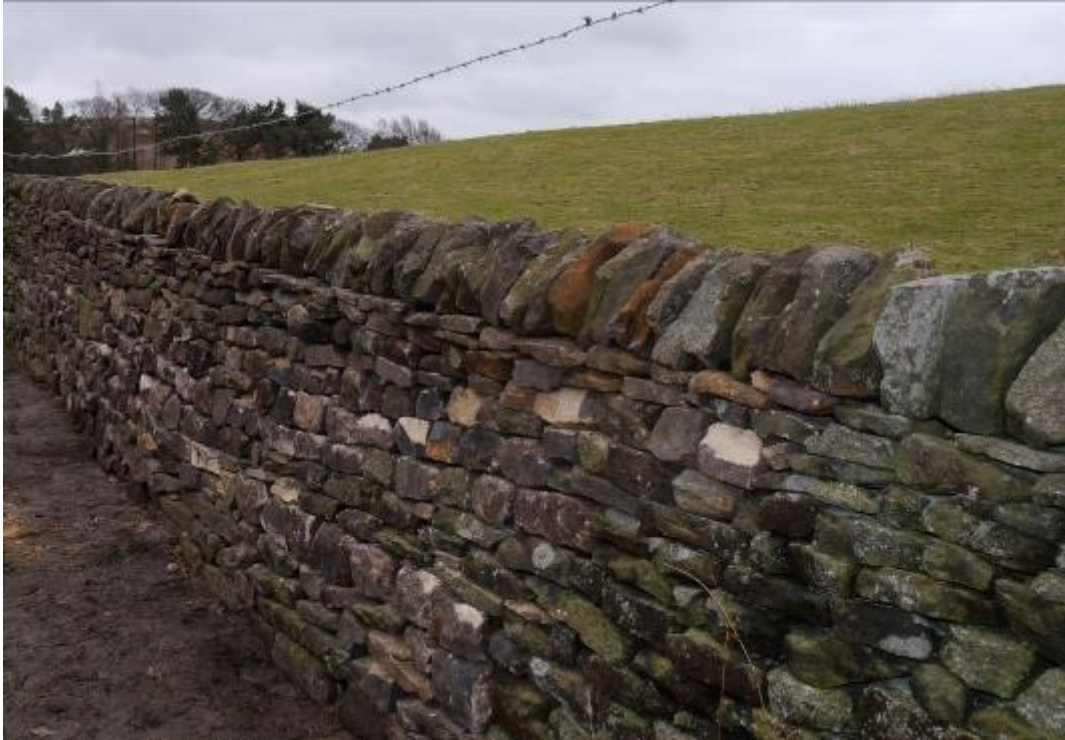
Here is the completed section of wall. This is the front elevation facing the road. It is important that the 'public-facing' side of the wall looks good. The coping stones are level. The joints are staggered for strength. This wall separates a stock field from the road.
